SHEAROGRAPHIC ANALYSIS OF TIRE AGING

2007.1773

Presented at the Spring 171st Technical Meeting of the

Rubber Division, American Chemical Society

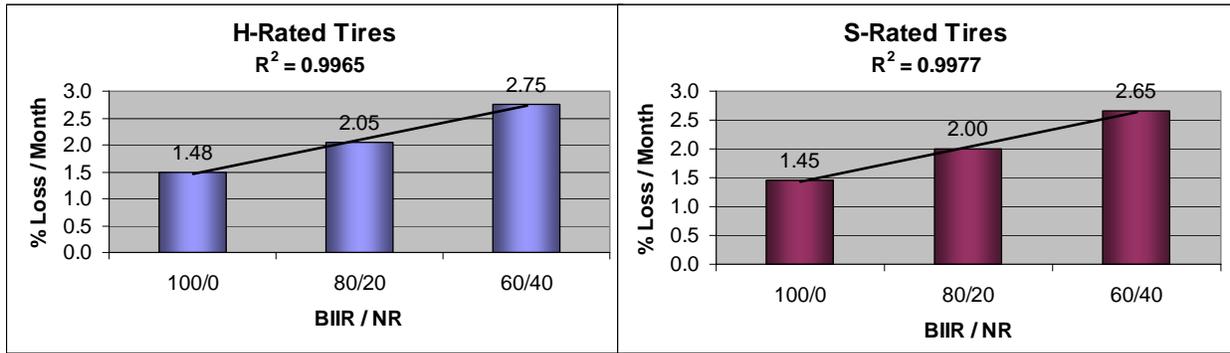
Figure 1. Inflation Pressure Retention Tire Test Results.

performance properties of inflation pressure retention (IPR), intracarcass pressure (ICP) and durability as measured in hours to failure on laboratory roadwheels. Innerliners with 100-phr bromobutyl rubber (BIIR) and 80/20 and 60/40 blends of BIIR/natural rubber were studied in P205/60 HR15 and P205/60 SR15 radial passenger tires. Tires with a 100-phr bromobutyl innerliner had the lowest IPR (Figure 1), lowest ICP (Figure 2) and highest laboratory roadwheel durability values (Figure 3).

Tire inflation pressure retention loss rate values (IPR; see Figure 1, $R^2 > 0.99$) and intracarcass pressure (ICP; see Figure 2, $R^2 > 0.96$) values for both the P205/60 HR15 and P205/60 SR15 sets of radial passenger tires decreased linearly with increasing bromobutyl rubber content in the innerliner compound. Statistically significant quantitative correlations were obtained. The tire having a 100-phr bromobutyl rubber innerliner has the desirably lowest Tire IPR loss rate and Tire ICP values regardless of the speed rating⁸⁻¹¹.

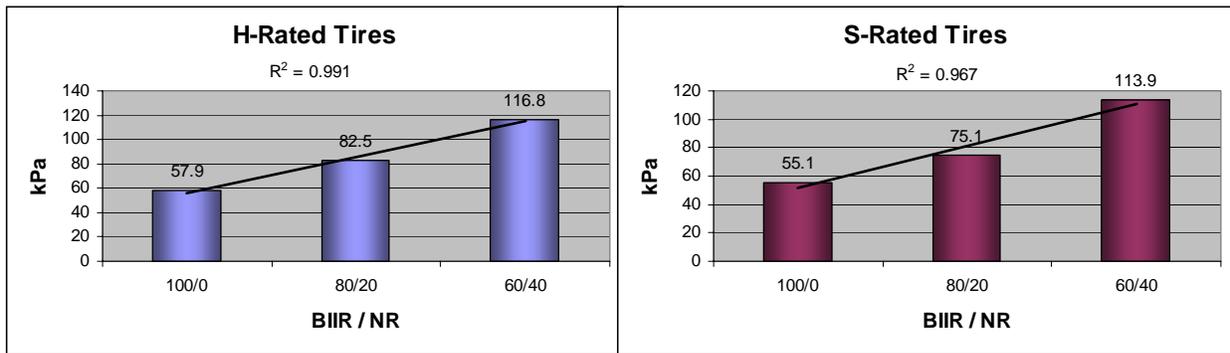
Figure 2. Intracarcass Pressure Tire Test Results.

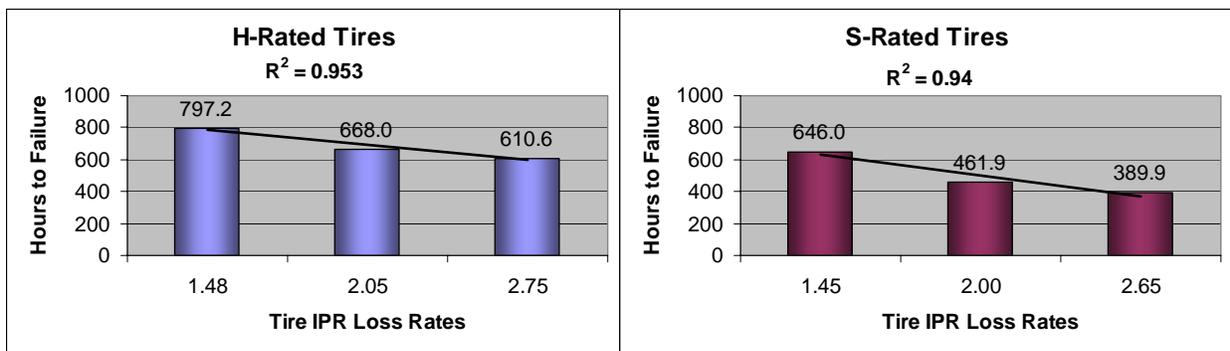
Figure 3. Tread Separation Tire Roadwheel (28.5 cm) Durability Test Results.

(1) Tread Separation (28.5 cm diameter laboratory drum) at 80 km/h, see Figure 3¹¹,

For each of the three laboratory roadwheel durability tests, the tire having the highest bromobutyl rubber content affording the lowest tire inflation pressure retention loss values performed best as determined by the longest number of hours run on the roadwheel before failing by a belt area separation. For Tread Separation and FMVSS 109 roadwheel durability testing at 80 km/h, a statistical correlation ($R^2 \sim 0.95$) was obtained for Tire IPR (or bromobutyl rubber level in phr) to hours run until failure. No correlation was obtained for these P205/60 SR15 tires when tested at 120 km/h.

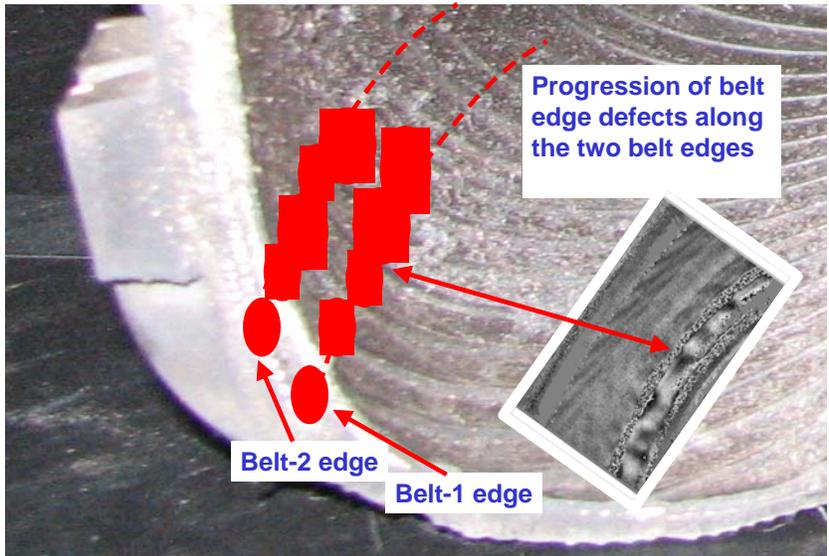
Figure 4. Tire Cross Section Highlighting the Belt-Edge Area of Interest and Showing an Example of a Shearography Pattern Obtained (see insert).

Shearography¹³ was performed using an ITT Compact (SDS Systemtechnik GmbH) instrument in the Akron Rubber Development Laboratory in Akron, Ohio. Measurements, for example see Figure 4, were taken for new tires, oven-aged tires, and oven-aged tires that were run on the roadwheel by following the FMVSS 139 Endurance / SUL procedure until tire failure. A complete 360 degree view of the tire is obtained in nine consecutive 40° pictures, see Figure 5.

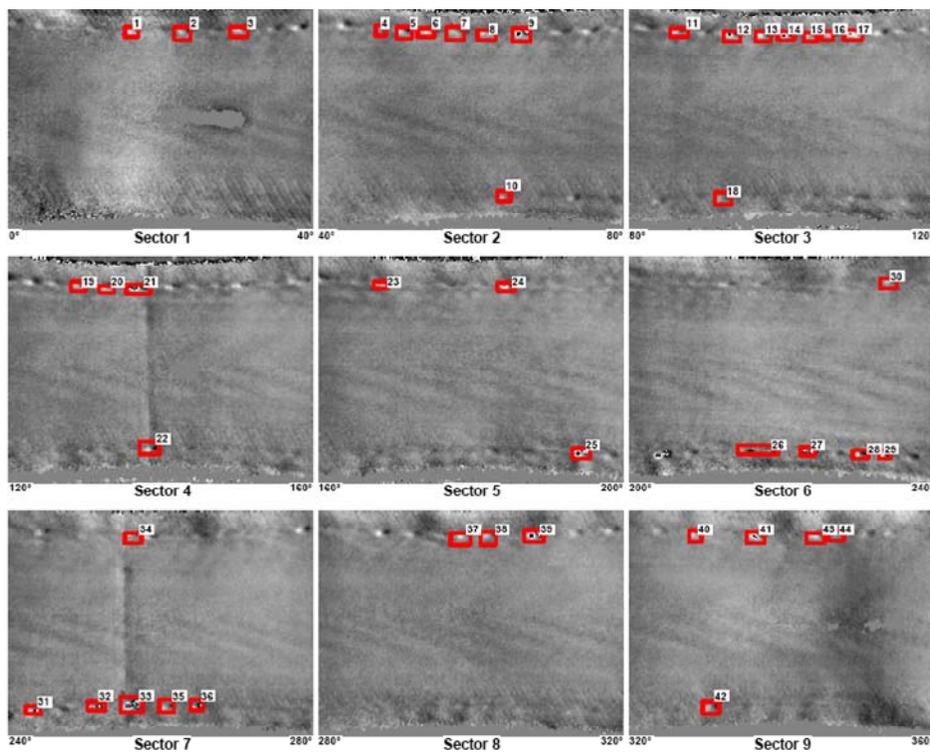
Figure 5. Nine 40-degree Shearographic Sections of the Belt-Edge Areas Showing a 360-degree View of Surface Deformations (denoted by boxes) Representing Internal Defects.

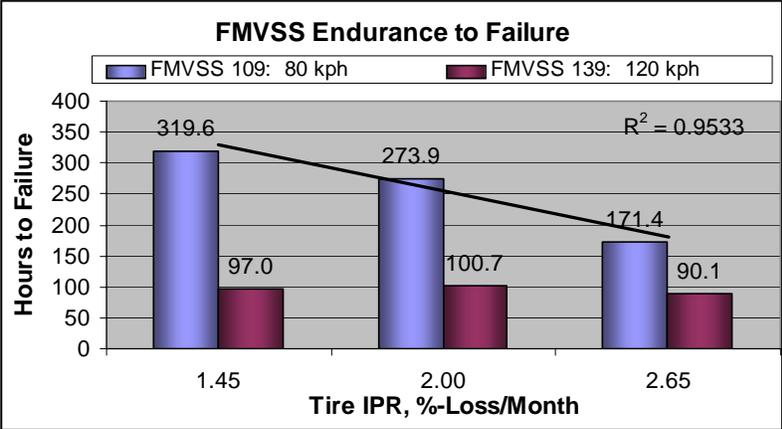
Figure 6. FMVSS 109 (to failure) and FMVSS 139 Endurance (to failure) Roadwheel (1.7 m) Durability Test Results for P205/60 SR15 Tires.

- (2) FMVSS 109 Endurance (1.7 m diameter laboratory wheel) at 80 km/h, but modified by continuing to test until failure after that tire had successfully completed the specified 34-hour roadwheel test and was inspected, see Figure 6, and
- (3) FMVSS 139 Endurance (1.7 m diameter laboratory wheel) at 120 km/h, but modified by continuing to test until failure after that tire had successfully completed the specified 34-hour roadwheel test and was inspected, see also Figure 6.

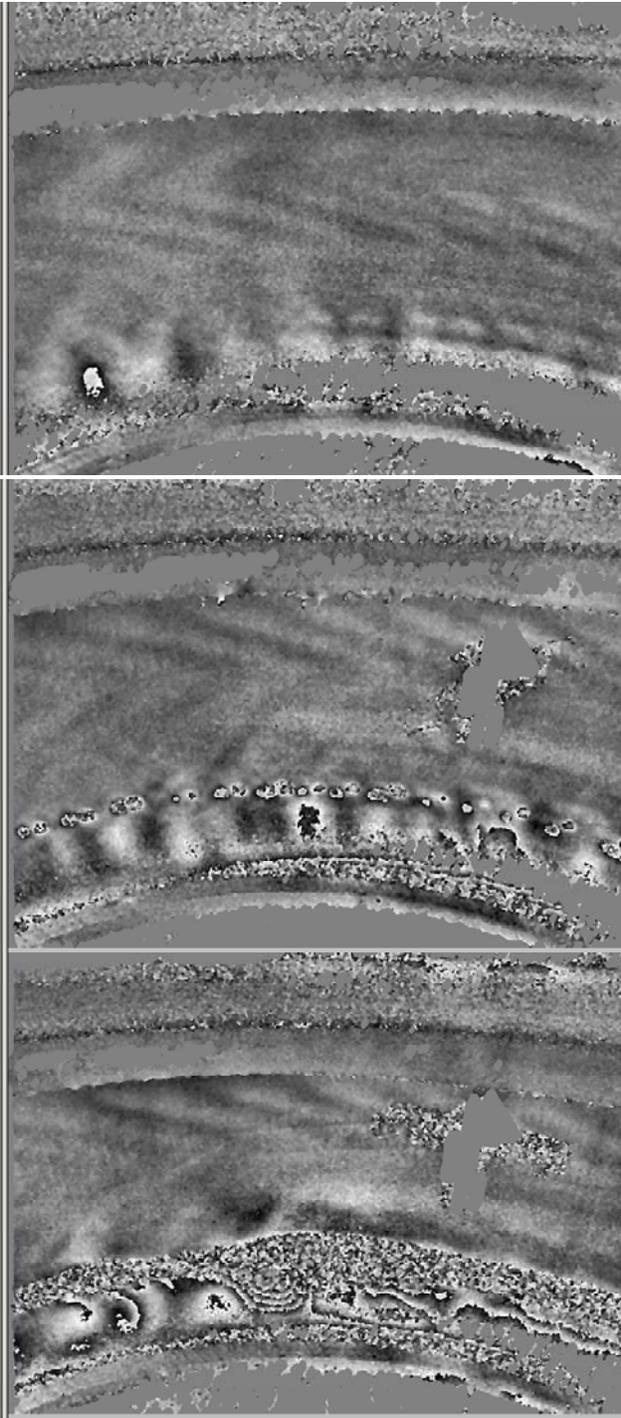
Figure 7. Example Shearography Patterns for Tires After 34 Hours of Total Roadwheel Run Times: Tire with IPR = 1.45 (100-phr bromobutyl rubber) is top picture; Tire with IPR = 2.0 (80/20 BIIR/NR) is middle; and Tire with IPR = 2.65 (60/40 BIIR/NR) is bottom.

measurements show that extensive internal cracking is already occurring in the higher IPR tires, particularly the tire with IPR = 2.65 %-loss/month. Figure 7 shows an example of the shearography pattern obtained for each oven-aged tire (IPR = 1.45 (100-phr bromobutyl rubber), IPR = 2.0 (80/20 BIIR/NR), and IPR = 2.65 (60/40 BIIR/NR). After 34 hours of running on a roadwheel, there is essentially no cracking detectable by shearography for the tire with IPR = 1.45 (top picture), while belt edge cracking is detected for the tire with IPR = 2.0 (middle). Extensive cracking at the belt edge growing in-between the two belts is observed for the tire with the highest IPR = 2.65 loss rate value (bottom). Similar results were observed after 22, 28, 34, 38, and 42 hours of roadwheel testing.

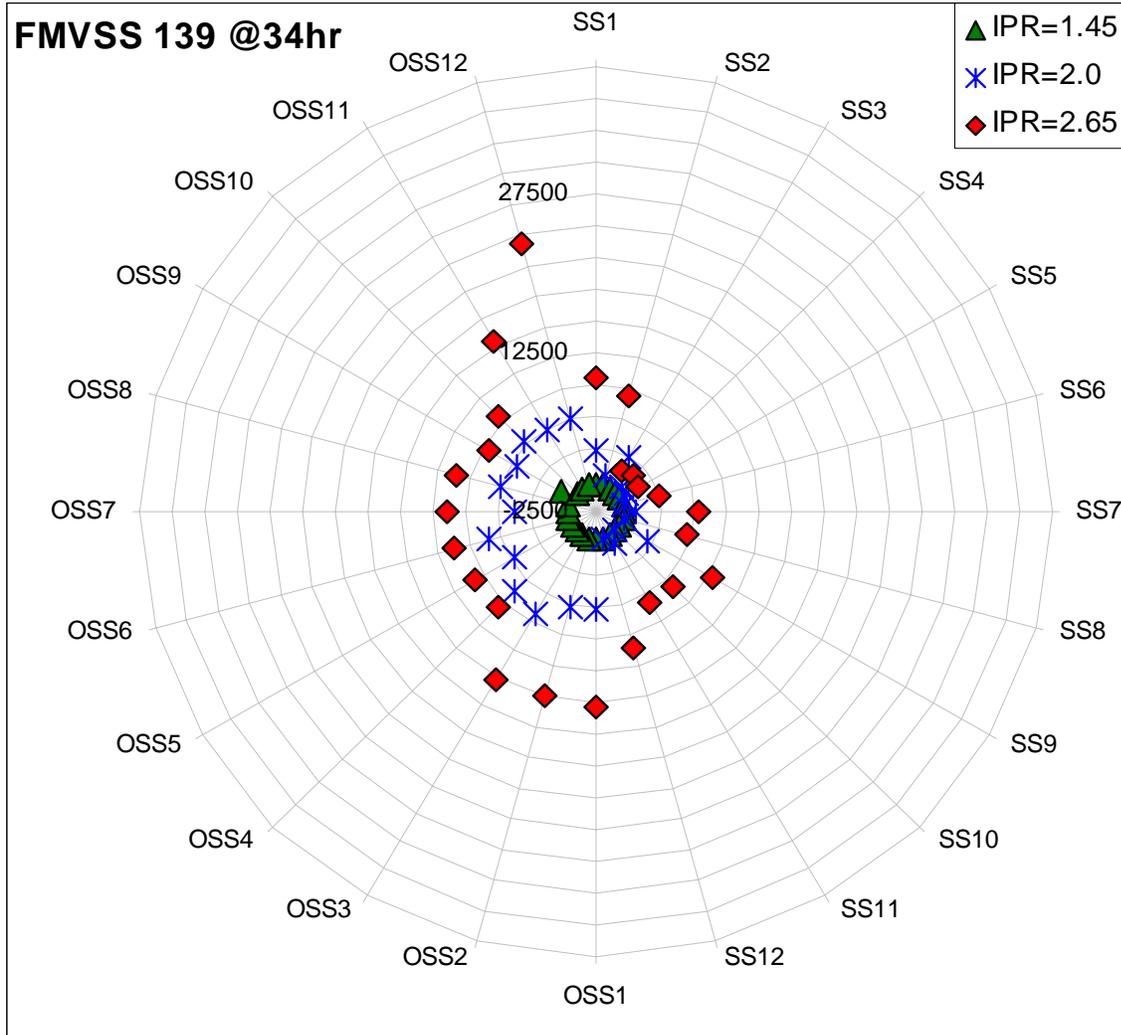
Figure 8. Radar Chart of Integrated Cracking Obtained by Shearography of Oven-aged Tires after 34 Hours of Total Roadwheel Run Time: Tire with IPR = 1.45 (100-phr bromobutyl rubber) is represented as green triangles; Tire with IPR = 2.0 (80/20 BIIR/NR) is blue x symbols; and Tire with IPR = 2.65 (60/40 BIIR/NR) is red diamonds.

Crack areas were determined for 24 circumferential sections, each spanning a 15 degree angle window around the tire to afford a 360-degree view of the cracking. Each window was integrated as a function of the roadwheel running time periods to obtain a time-dependent history of crack formation. Figure 8 is an example radar chart plotting the total cracking in each of the 24 windows measured after 34 hours of total roadwheel running time, which is the time period to complete the FMVSS 139 Endurance test. Recall that no flaws were observed for any tire by visual inspection.

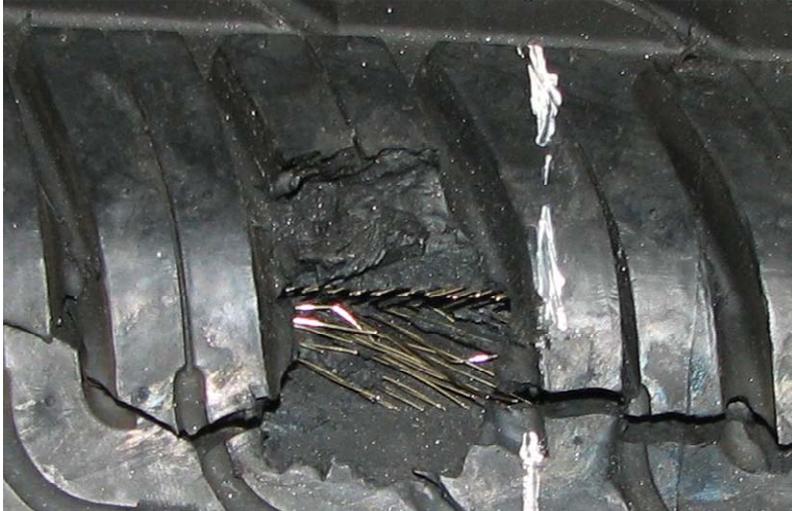
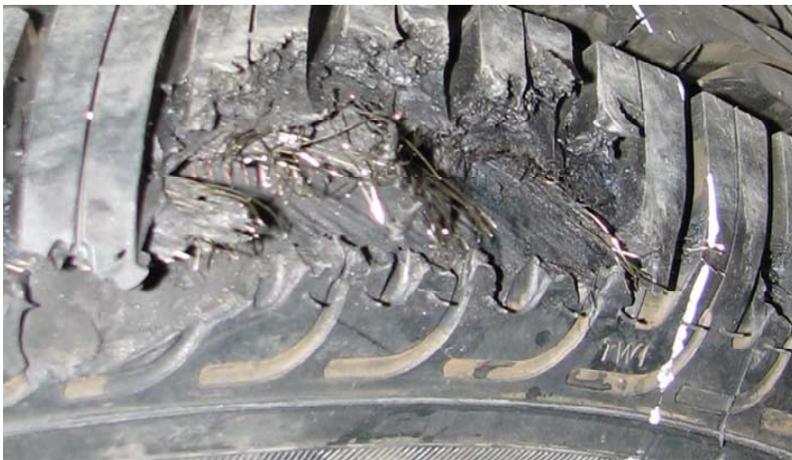
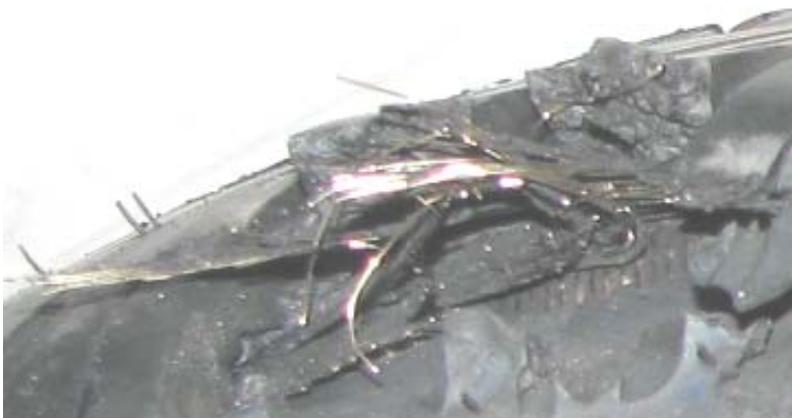
Figure 9. Photograph of Tire Section After Failure: Tire with IPR = 1.45 (100-phr bromobutyl rubber) failed at 55.8 hours (top picture); Tire with IPR = 2.0 (80/20 BIIR/NR) failed at 49.0 hours (middle); and Tire with IPR = 2.65 (60/40 BIIR/NR) failed at 39.7 hours (bottom).

Tire roadwheel testing was continued by applying the additional 10% load and running for another four-hour time period. The tire with the highest IPR = 2.65 %-loss/month value failed at 39.7 hours of total roadwheel running time at the 120% load step in the FMVSS 139 Endurance / Stepped-Up-Load test. The tire with IPR = 2.0 loss rate failed at 49.0 hours of total roadwheel running time at the 140% load step. The tire with the lowest IPR = 1.45 %-loss/month failed at 55.8 hours of total roadwheel running

time at the 160% load step. All three tires failed by a belt edge separation, see Figure 9.

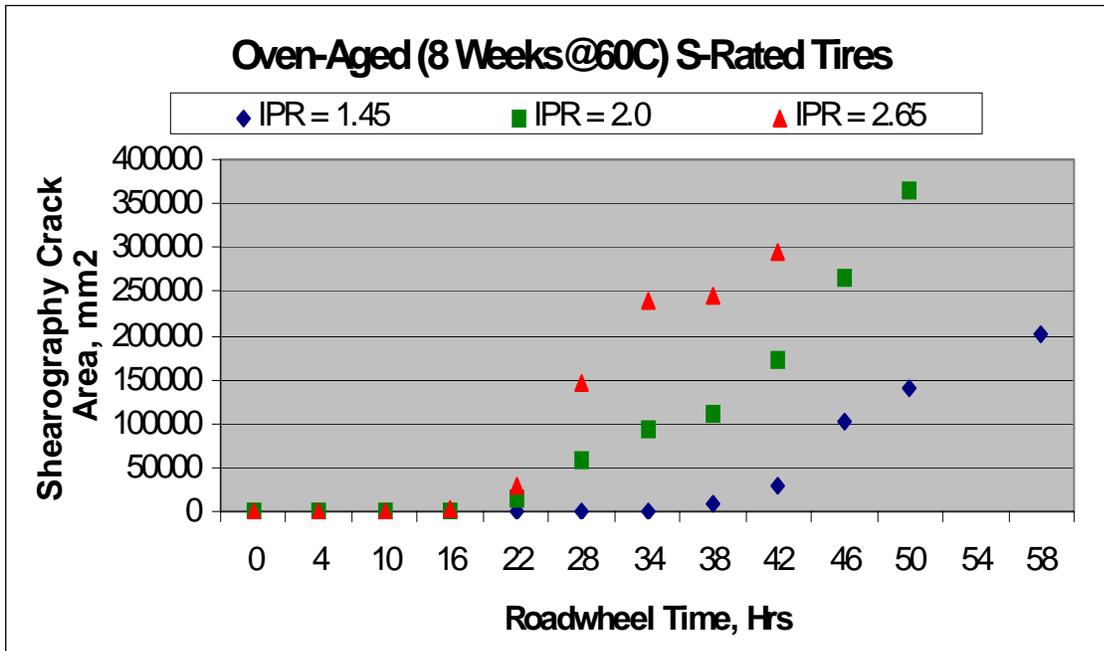
Figure 10. Total Shearography Crack Areas (mm²) for the Oven-aged and Roadwheel-tested P205/60 SR15 Tires as a Function of Roadwheel Run Times.

The crack areas in each of the 24 windows was integrated for each roadwheel time period in order to obtain a total crack area for the three oven-aged tires differing only in Tire IPR values as a result of the differing bromobutyl rubber levels used in the innerliner formulation, see Figure 10. Statistical analysis of cracking as a function of any specific roadwheel running time period clearly shows that belt area cracking can be quantitatively correlated ($R^2 > 0.98$) to Tire IPR loss rate values, for example see Figure 11. Similar results were observed after 22, 28, 34, 38, and 42 hours of roadwheel testing, but are not shown. Results were not obtained at longer time periods since the tire with IPR = 2.65 loss rate value failed at 39.7 hours of total testing time. Finally, statistical analysis also shows that the total time to failure on the laboratory roadwheel can also be quantitatively correlated ($R^2 = 0.99$) to Tire IPR loss rate values, see Figure 12.

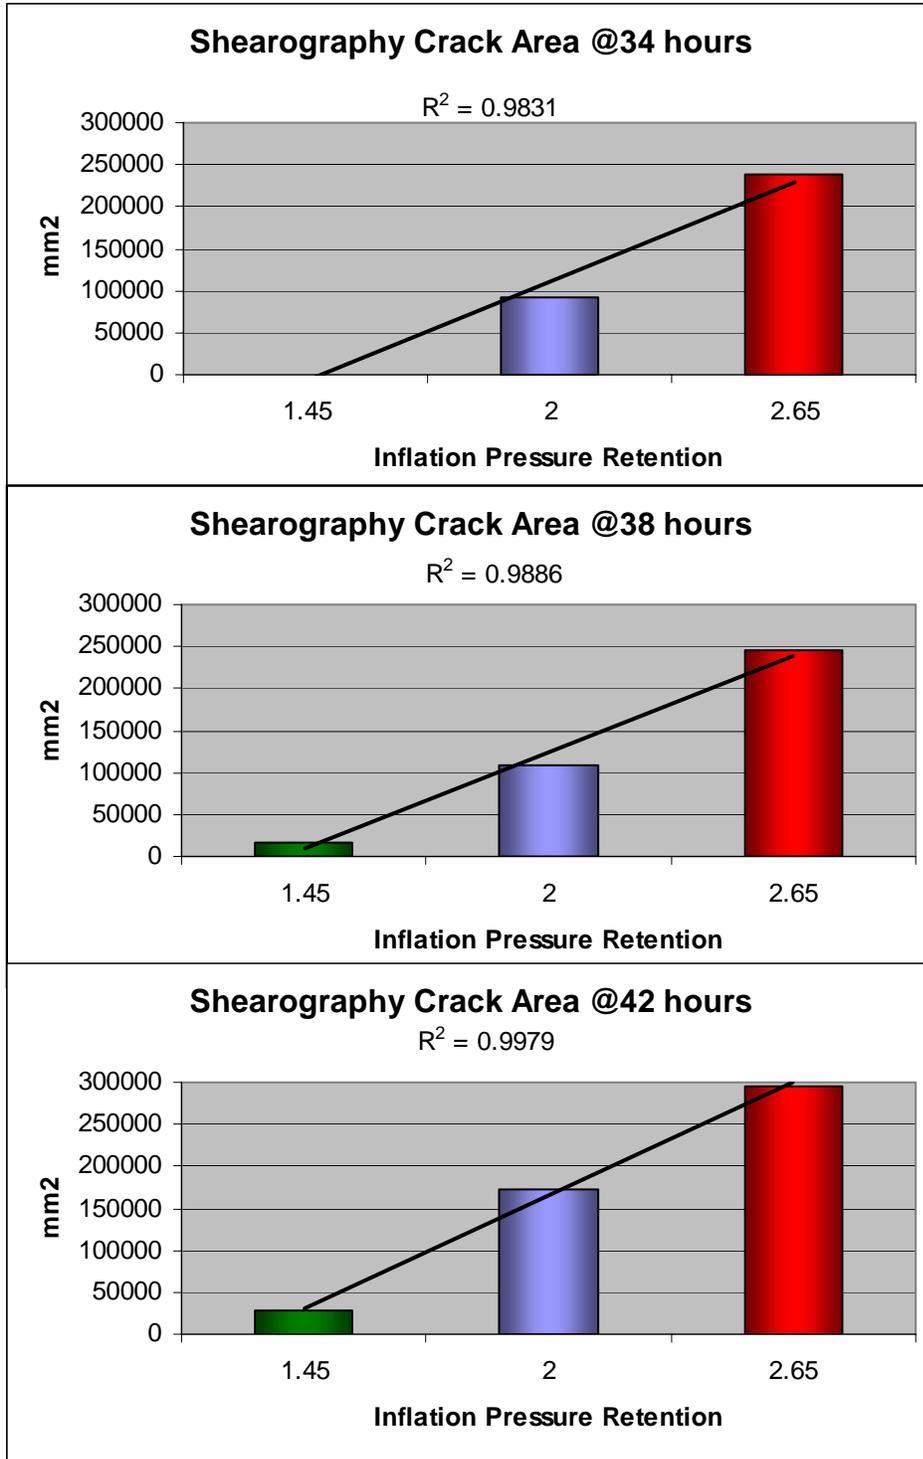
Figure 11. Correlation of Tire IPR Loss Rate Values (%/month) to Total Shearography Crack Areas (mm²) for the Oven-aged and Roadwheel-tested P205/60 SR15 Tires after 34 (top graph), 38 (middle), and 42 Hours (bottom) of Total Running Time.

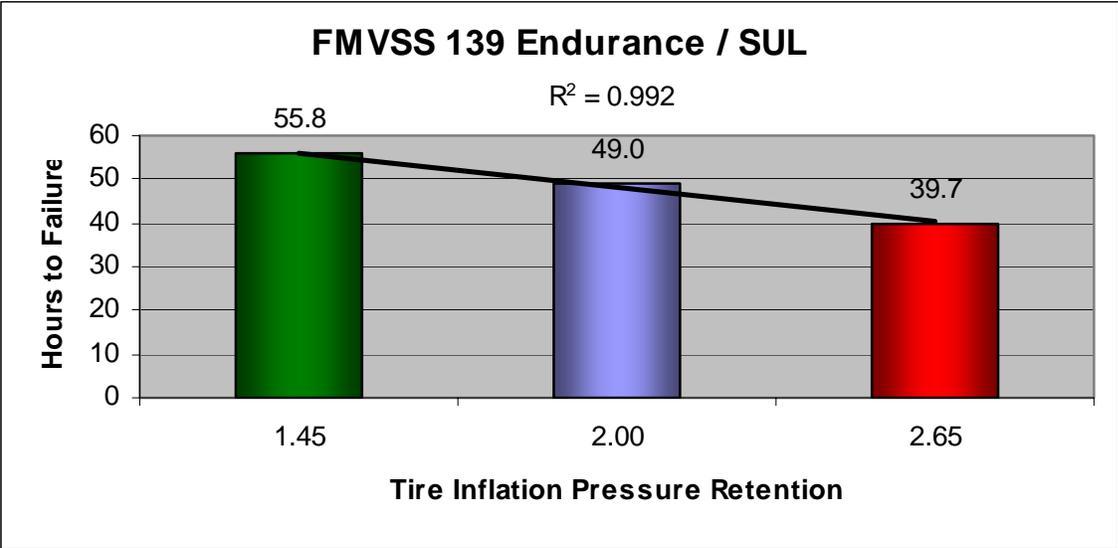
Figure 12. Correlation of Tire IPR Loss Rate Values (%/month) to Total Hours to Failure on the Laboratory Roadwheel for oven-aged P205/60 SR15 Tires.
